**ENHANCED PRELIMINARY ASSESSMENT REPORT
FOR TOOEELE ARMY DEPOT - NORTH AREA
TOOELE, UTAH**

**USAEC Contract DAAA15-93-D-0006
Delivery Order 001**

October 5, 1994

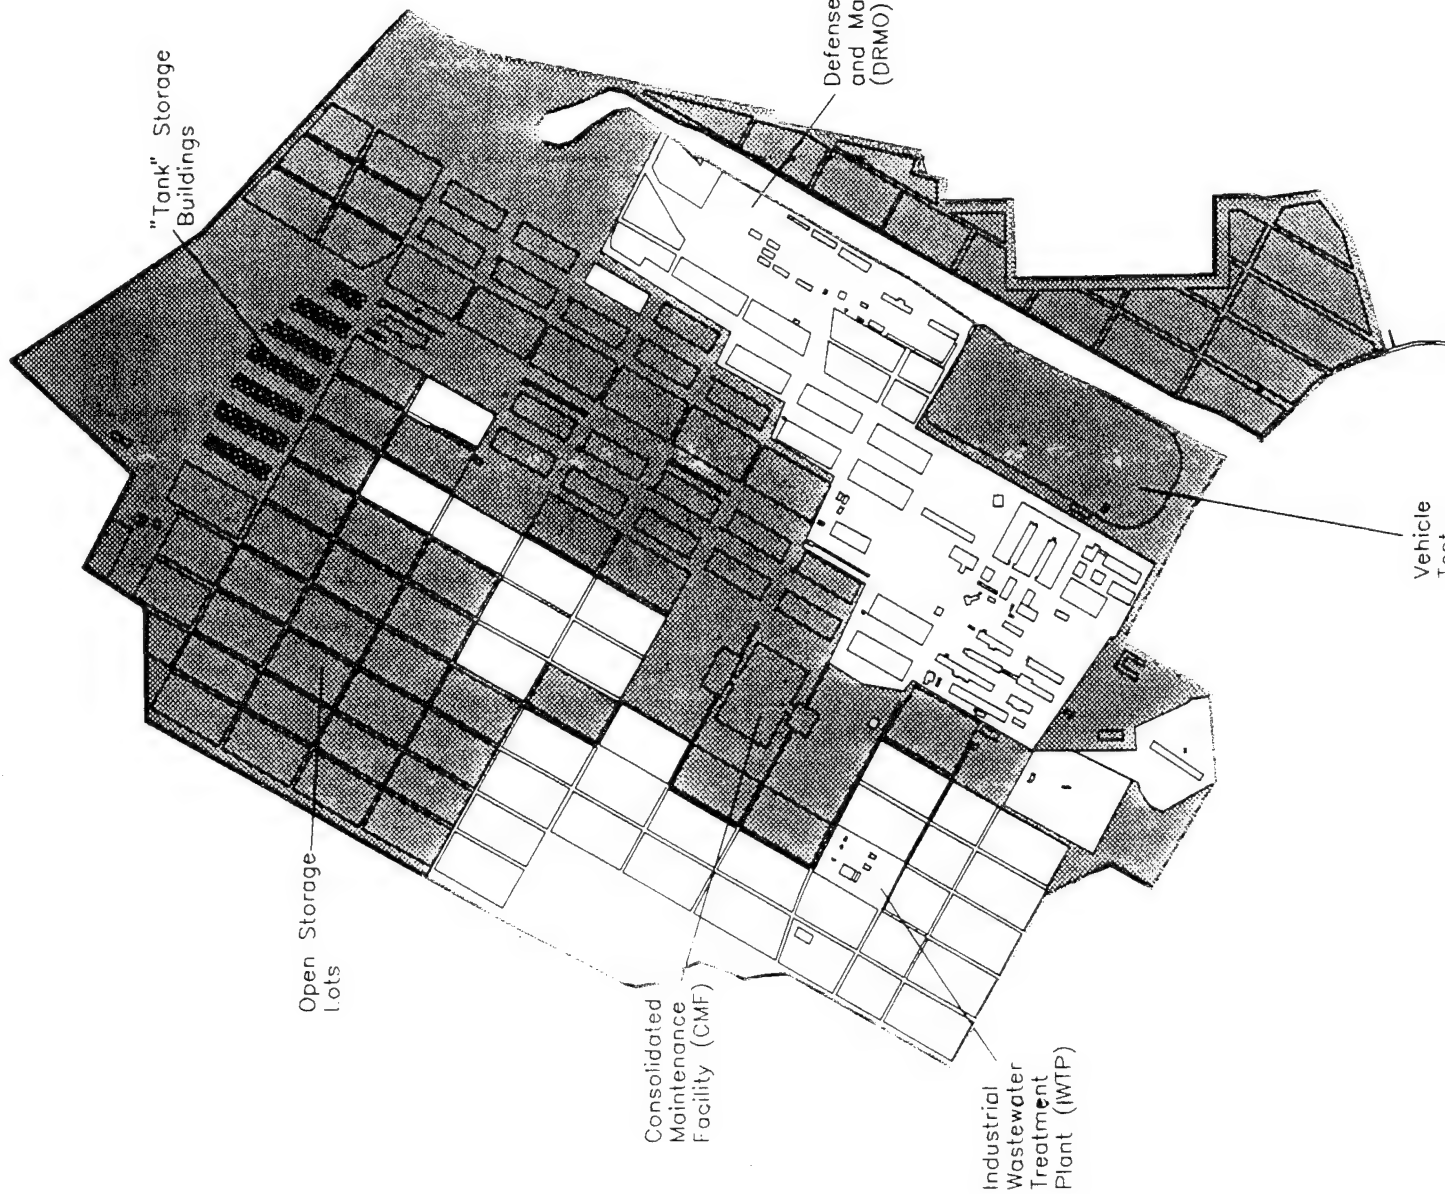
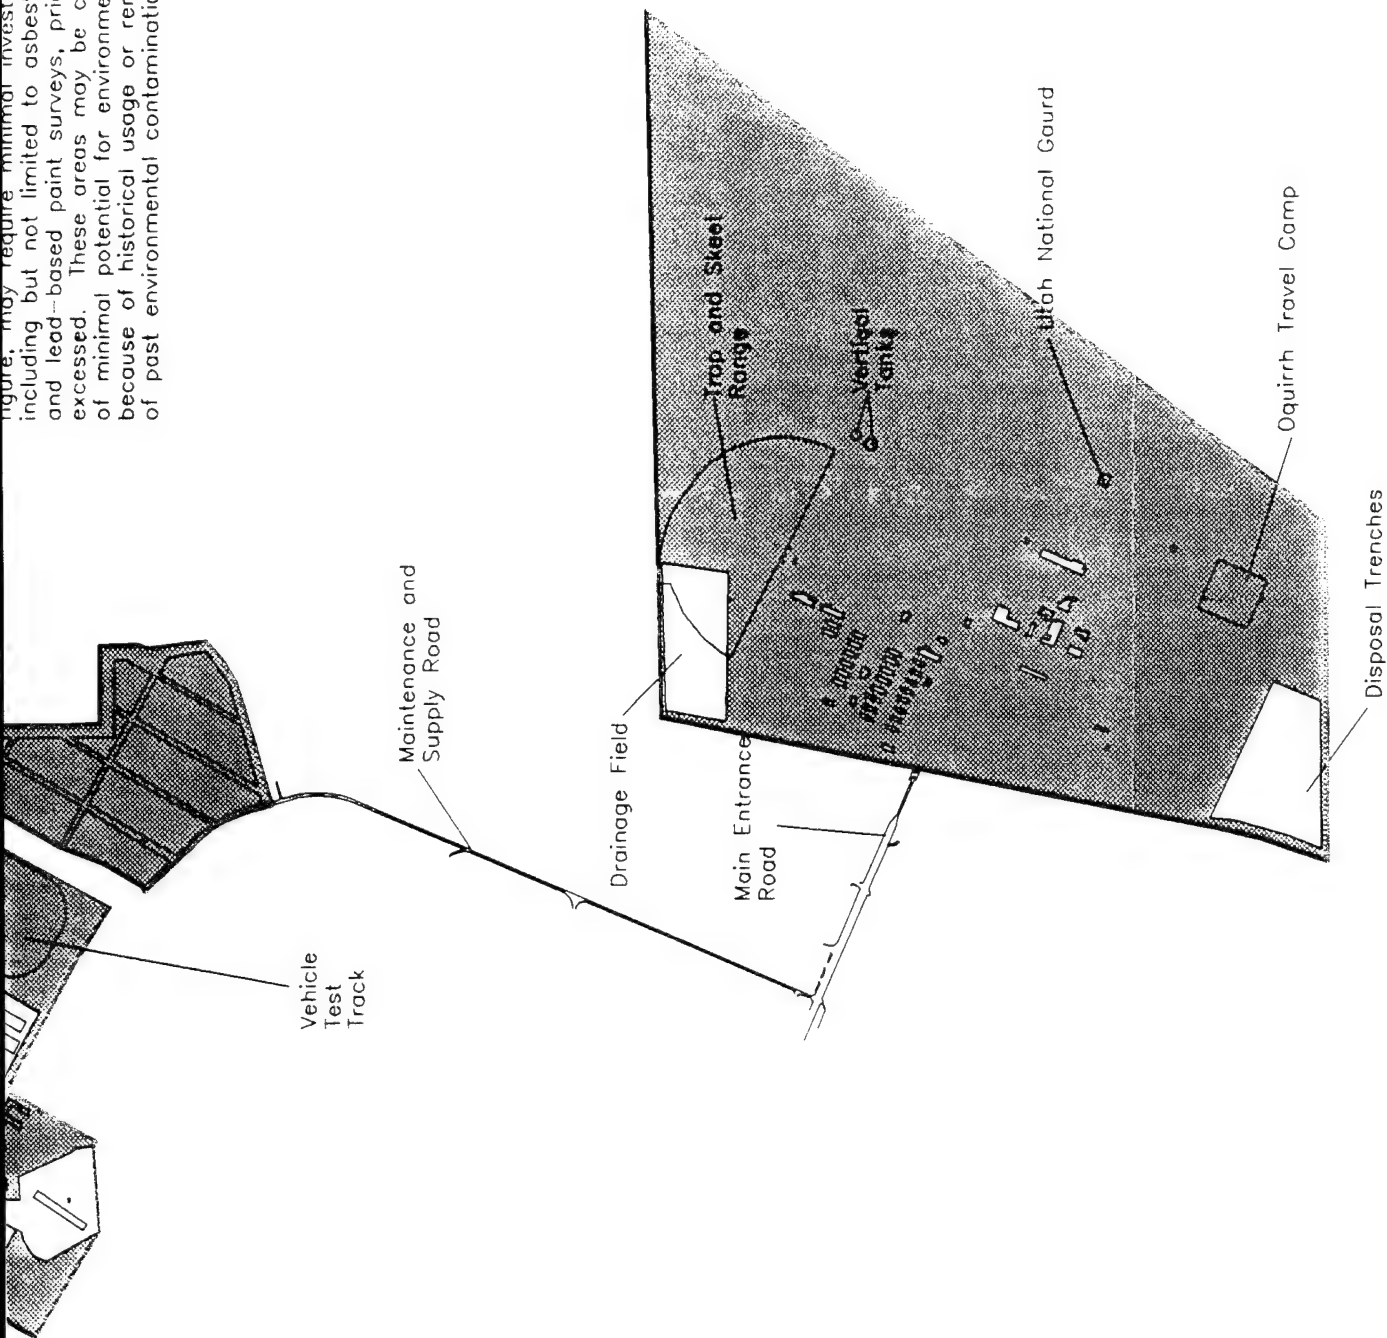
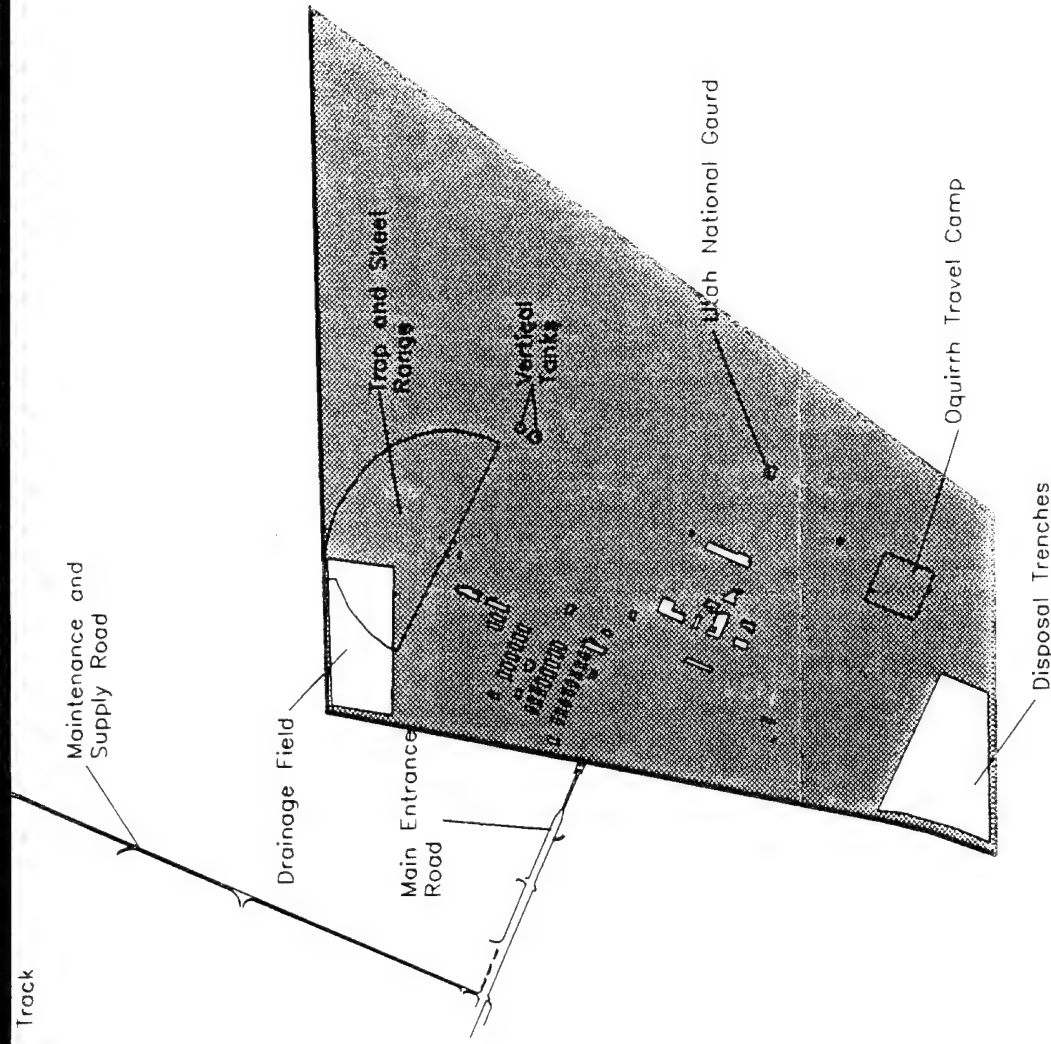
Figure 5-1

These areas with minimal potential for environmental problems are shown in Figure 5-1. It should be noted that even though the above areas may have a minimal potential for environmental problems, the groundwater plume underlies portions of these areas. Also, this report and the conditions represented within are limited to conditions observed and reported at the time of the site visits. It is possible that conditions may have changed since the project site visits or historical practices not uncovered may impact the investigation results.

NOTE: The areas with minimal potential for environmental problems, identified on this figure, may require minimal investigation, including but not limited to asbestos, radon, and lead-based paint surveys, prior to being exceeded. These areas may be considered of minimal potential for environmental impact because of historical usage or remediation of past environmental contamination.
